Scaled data based on original data using  
LM-79-08 Approved Method: Electrical and Photometric Measurements of Solid-State  
Lighting Products

Test Report Prepared for

Cooper Lighting Solutions

Report Number: P307212

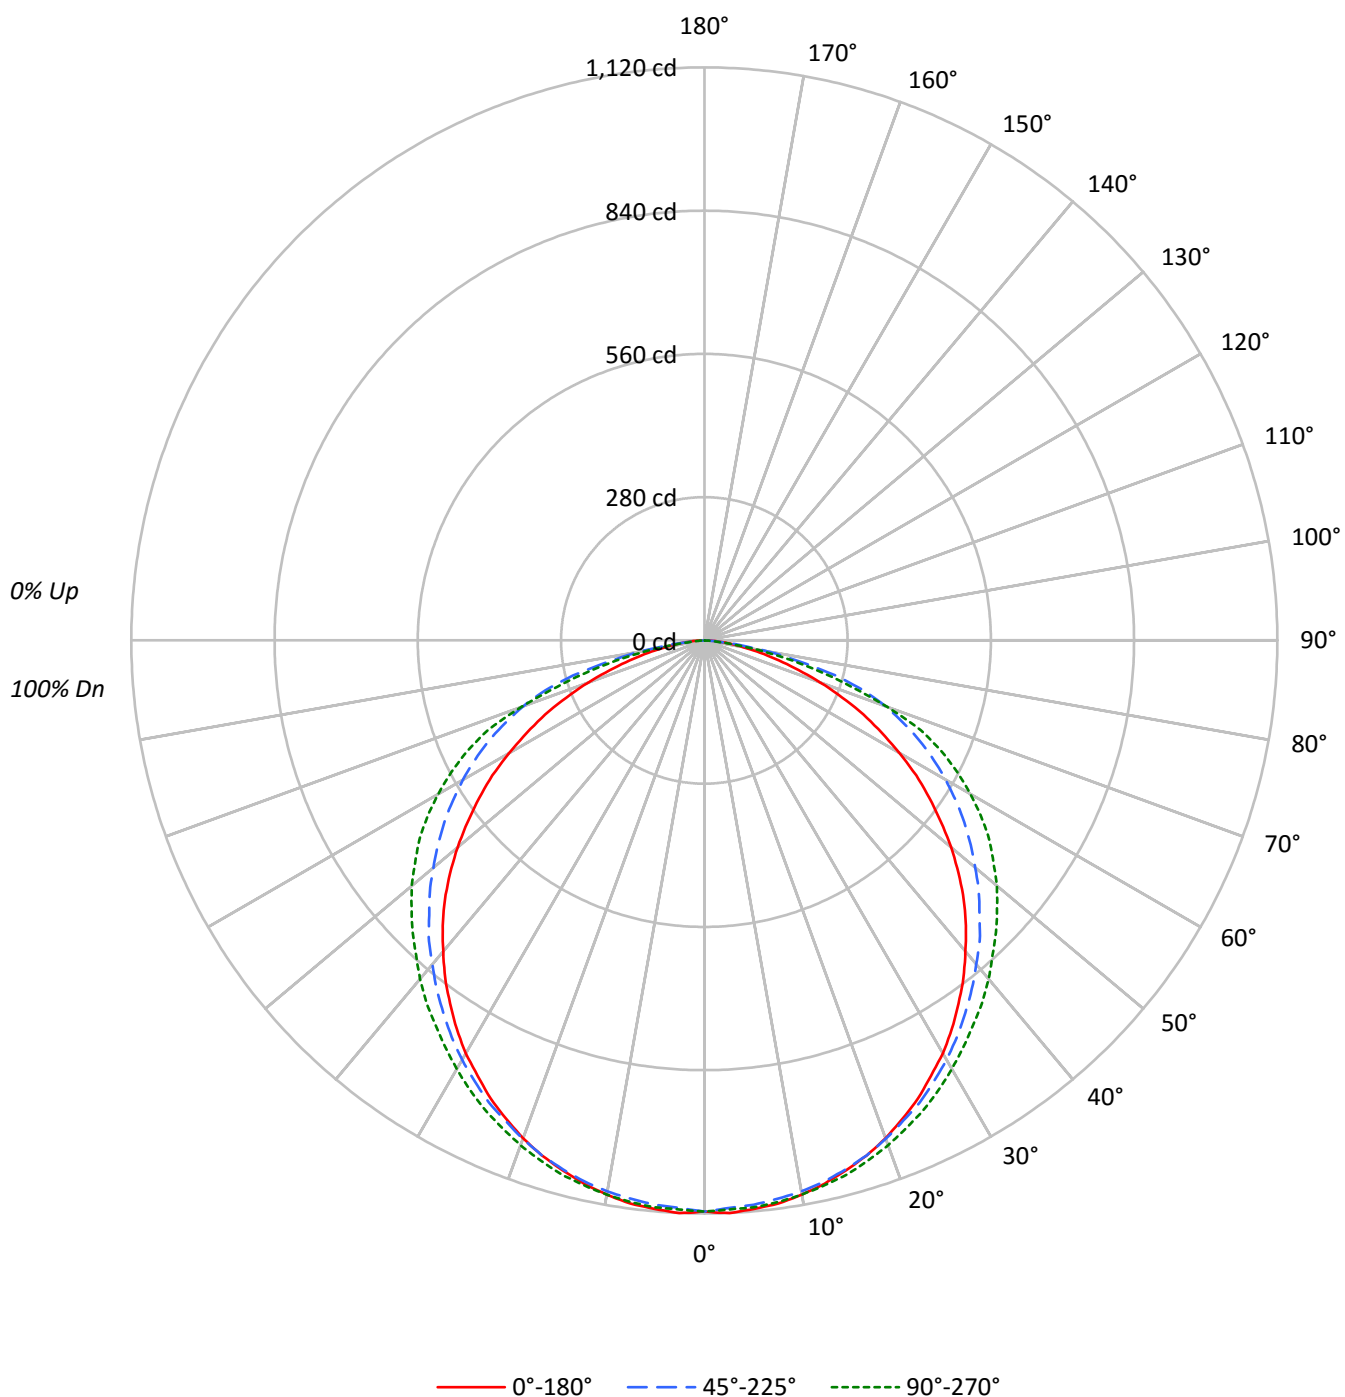
### Luminous Intensity Polar Plot
