Scaled data based on original data using  
LM-79-08 Approved Method: Electrical and Photometric Measurements of Solid-  
State Lighting Products

Test Report Prepared for  
Cooper Lighting Solutions  
(formerly Eaton)

Report Number: P963607

Luminaire Tested: **NAV-SB3A-760-U-T2R-HSS**

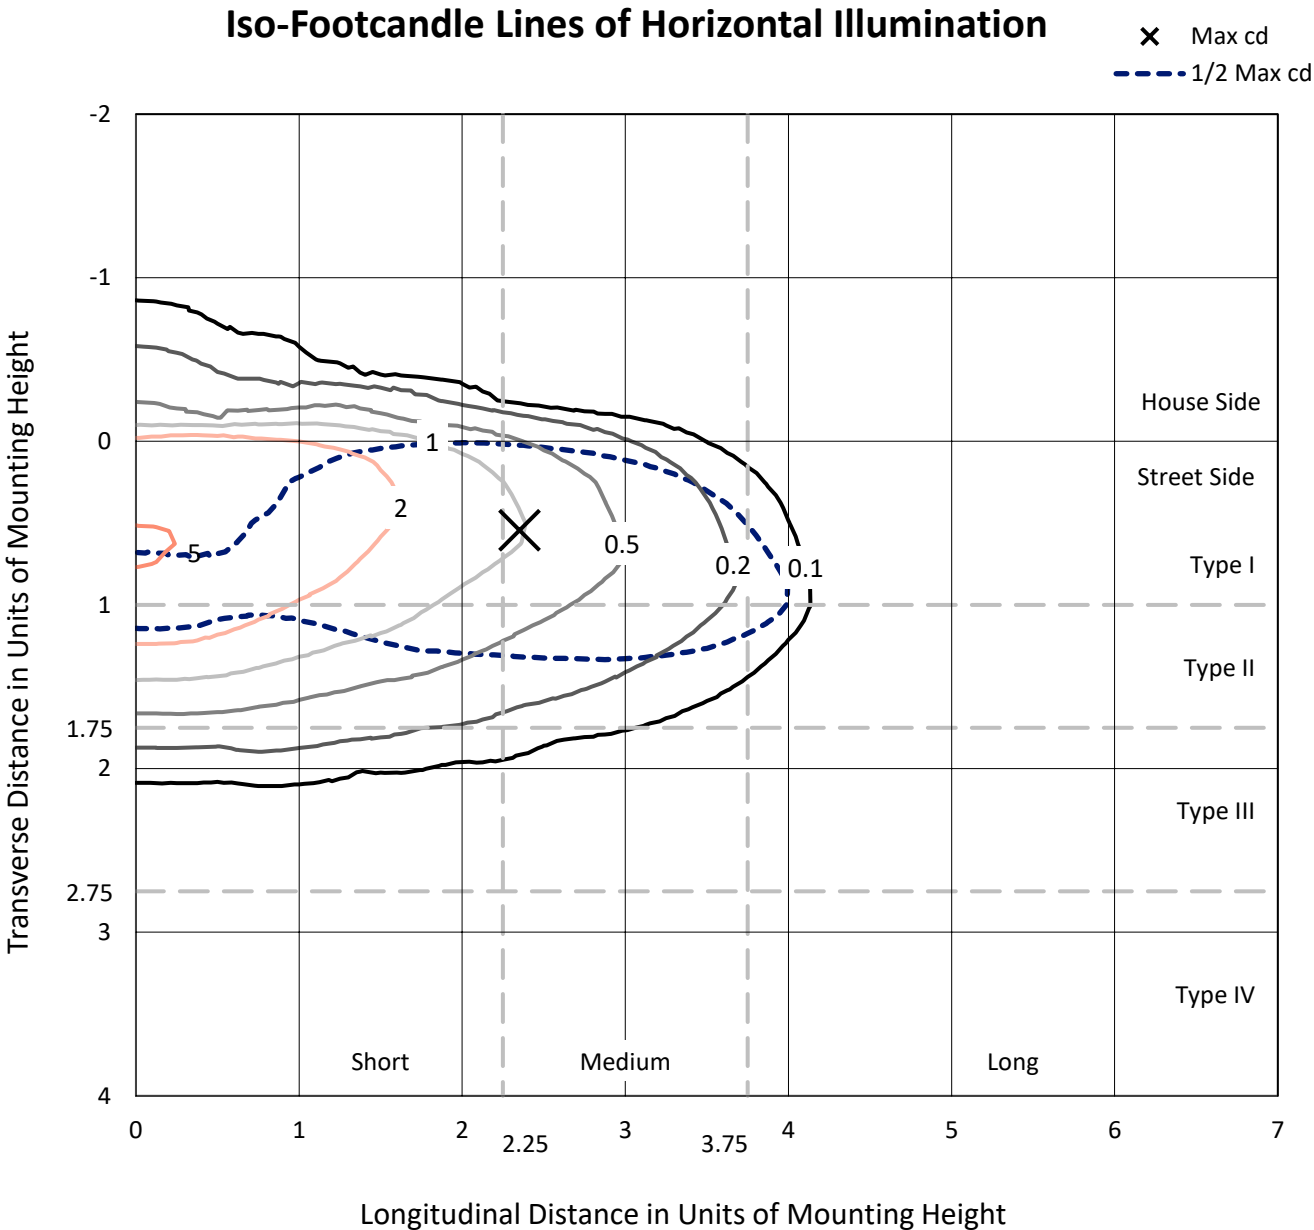
Based on 25 foot mounting height. Maximum calculated value = 5.3 fc  
Type II - Medium - N/A

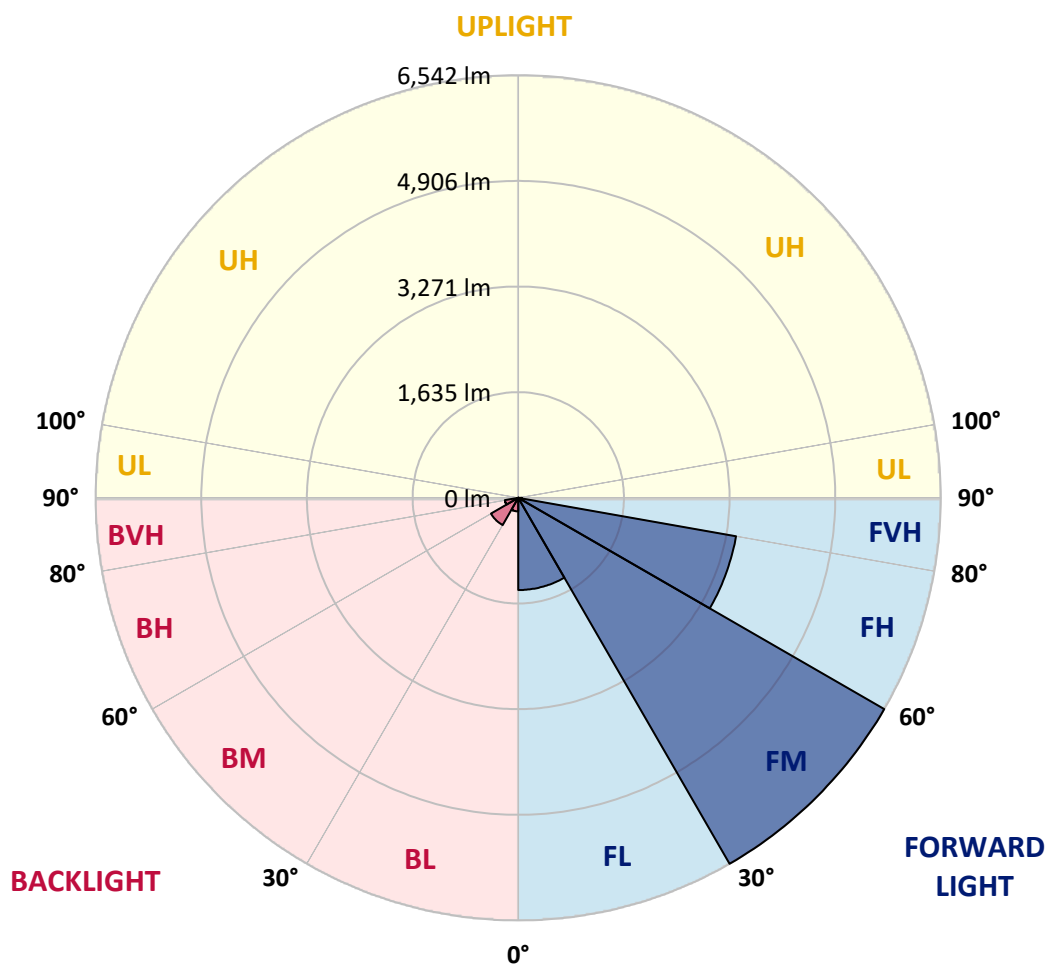
**BUG Rating: B1-U0-G2**

Type II Medium
