Scaled data based on original data using
LM-79-08 Approved Method: Electrical and Photometric Measurements of Solid-
State Lighting Products

Test Report Prepared for
Cooper Lighting Solutions
(formerly Eaton)

Report Number: P951851

Luminaire Tested: **GALN-SB5D-850-U-SL3-HSS**

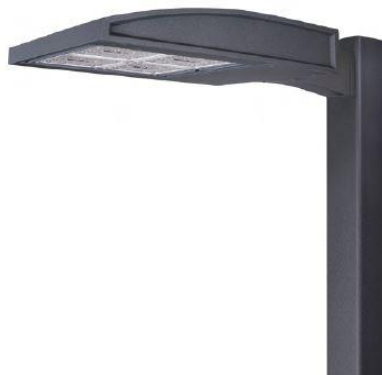
Lumens per Lamp: N/A
Luminaire Lumens: 39596 lumens
Efficiency: N/A
Efficacy: 108.5 lumens/watt
Luminous Opening: Rectangular (W 1.5' x L: 1' x H: 0')
IES Classification: Type III - Medium
BUG Rating: B3 - U0 - G5

Input Watts (W): 364.9
Input Voltage (V): NR
Input Current (Ain): NR
Voltage Rise (V): NR
Power Factor: NR
Total Harmonic Distortion (THDi): NR
Frequency (hertz): 60
Stabilization Time: NR
Operation Time: NR
Ambient Temperature (°C): NR
Test Distance: 24 FT
